UNITED STATES DEPARTMENT OF AGRICULTURE
SOIL CONSERVATION SERVICE
H. H. Bennett, Chief

STUDIES OF THE USE OF PERVIOUS FENCE FOR STREAMBANK REVETMENT

*John T. O'Brien
Hydraulic Engineer*

Report No. A-70.1
Prepared under Contract ASC(OR-O)3304

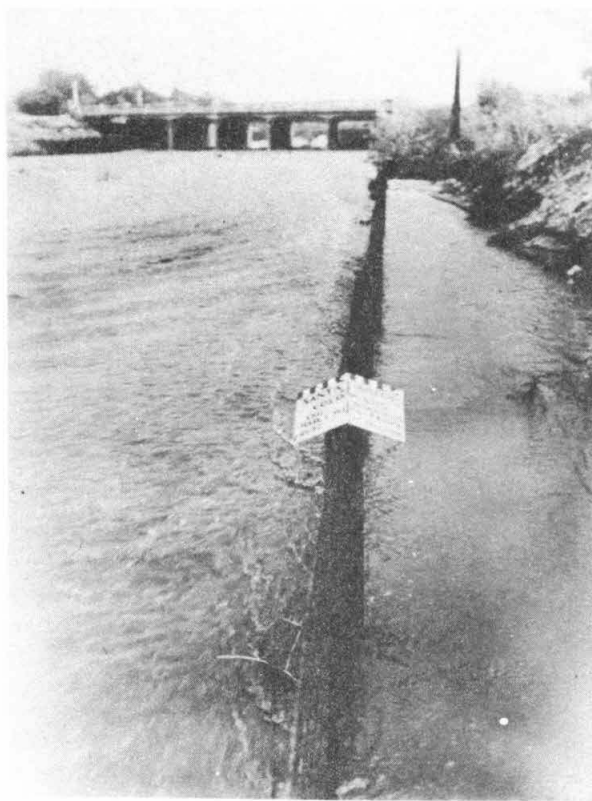
Frontispiece - FLOW ALONG CHANNELS AND BANK SIDES OF FENCE

Looking downstream along rail and wire fence. Note standing waves off debris on fence and sediment deposits upstream from groin in right background. Flow depth in channel is about 1 ft and total flow about 200 cfs.

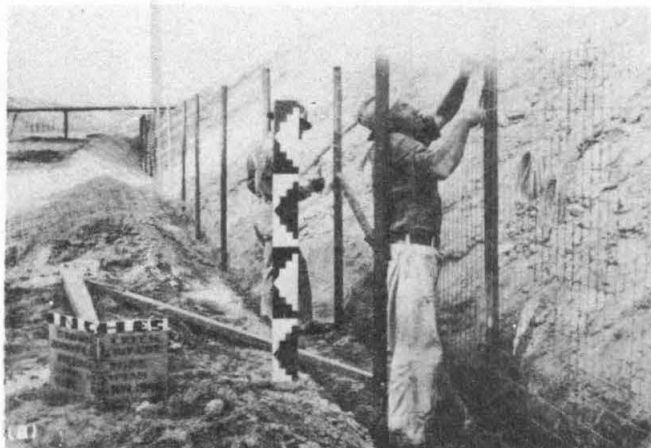
Fig. 1 - PIPE AND WIRE REVETMENT UNDER CONSTRUCTION

Pipe is 2 1/4 in. diameter boiler tubes and fencing is 6 ft wide welded wire with 2-in. by 4 in. openings. (a) Looking upstream at inside of double fence. Note brace. Workmen are tying fencing to pipes. (b) Fencing being stretched. Braces will be left in place. (c) Completed fence. Trench will be backfilled. (d) Pipes (boiler tubes) being driven with portable pile driver. Hammer weighs about 500 lbs.

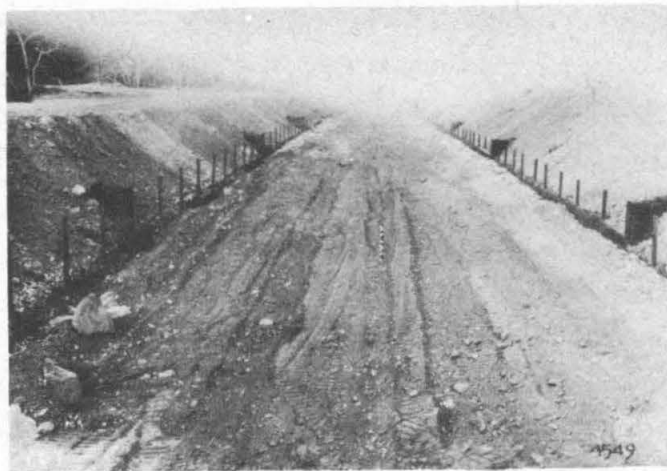
Fig. 3 - DETAILS OF GROIN

Used with rail and wire fence. Angle is 45° with flow. Groins point downstream. (a) Framework. Elwood wire used on groin. Top of welded wire on fence is about at channel bottom. Note timbers bolted to rails. (b) Brush placed between fencing. Note depth to which it is carried. (c) Looking upstream at partially completed channel. Width is about 50 ft and groins are spaced 50 ft. Note cables slung between rails. These are intended to help hold fence together should parts be undercut.

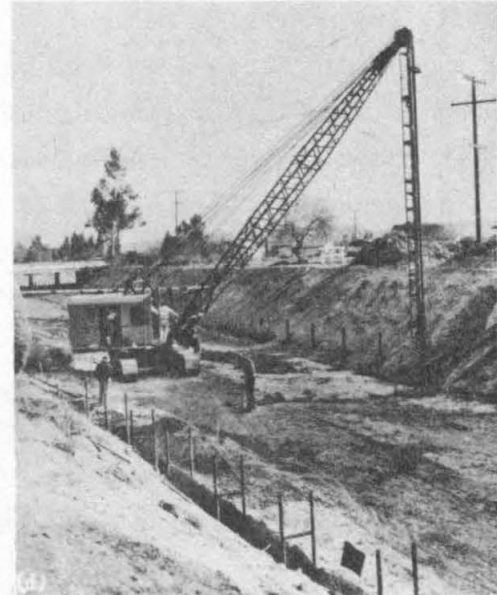
Fig. 4 - SHEET STEEL GRADE STABILIZER

Stabilizers shown are constructed basically of 1/4 in. thick sheet steel and rails. (a) Looking at upstream face. Observer's hands rest on crest of stabilizer. Note cables tied to dead men as restraints against overturning. (b) Backfilling after repairing scour under stabilizer induced by flow through a gopher hole. (c) Looking at upstream face. Crest is pitched 1/2 ft in 18 ft (half width of channel). (d) Drag line using 2000 lb hammer to drive rails. Grade stabilizer to be erected here. Fence in foreground has yet to be braced laterally.

Figure 4 shows a grade stabilizer designed mainly of sheet steel and railroad rails. The rails are driven about 25 ft. into the channel bed and the sheet steel facing is carried about 15 ft. below the crest and into the bank. A small stilling basin to dampen the overfall is usually built of field stone and mortar or in some cases a brush mat is used.

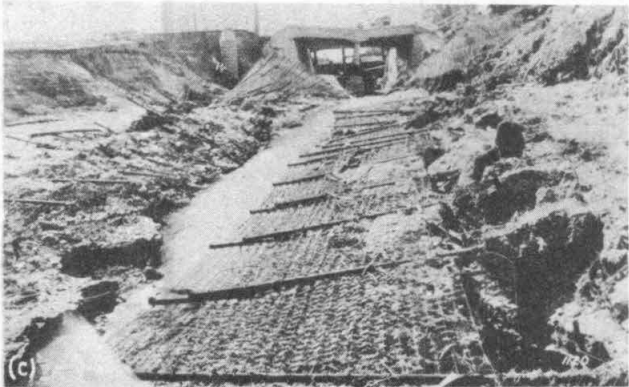
Fig. 6 - PIPE AND WIRE AND TIMBER AND WIRE FENCES AFTER FLOWS

(a) Severely undercut pipe and wire fence repaired by driving second row of pipes and adding new fencing. (b) Looking upstream at timber and wire and pipe and wire fences in same channel. Note horizontal fencing along right bank. Should the channel bed be eroded this fencing would swing downwards toward the vertical to help protect bank. (c) Pipe and wire fence which failed due to undercutting and lack of lateral braces. Looking downstream at broken control point. (d) Pipe and wire fence set purposely along sloping channel bank. Looking upstream at outside of curve. This fence survived a flood of 1500 cfs which topped it by 1 ft (see Bradley reference). Pipe is $2 \frac{7}{8}$ in. in diameter, 14 ft long driven 8 ft into the bed at 1 on $1\frac{1}{2}$ slope and held in place by a dead man at each pipe.

Many of the earlier fence revetments in Southern California were built in streams which originally carried a heavy sediment load, most of which was picked up in steep mountain gorges and spilled into the valleys below. Through the years debris dams were built in the mountains to catch part of this load to reduce the flood hazards in the valleys. Therefore, the flow into the channels below the dams was usually deficient in sediment and the channel beds were scoured to relieve this deficiency. In some cases this action was so violent that artificial controls which stabilized the channel grade were undermined and/or cut around and the fences upstream were undercut and failed as shown in Fig. 6. Distortion of the bed by sand waves produced local scour that

Debris, when closely packed in the fence as shown in Fig. 10, gives the fence an appearance of semi-imperviousness as in some of the fences inspected in Orange (California) County. Here, as shown in Fig. 6-d, the pipes are driven at a 1 on 1/2 slope toward the banks. The fencing is fastened on the bank side of the pipes and backed by closely-packed native reeds. The soil is backfilled against the reeds to form with its opposite a bank-lined trapezoidal cross section. As observed and reported by Bradley (6), such a fence was able to withstand a large flood without serious damage. However, fences of this type were not the particular concern of this investigation.

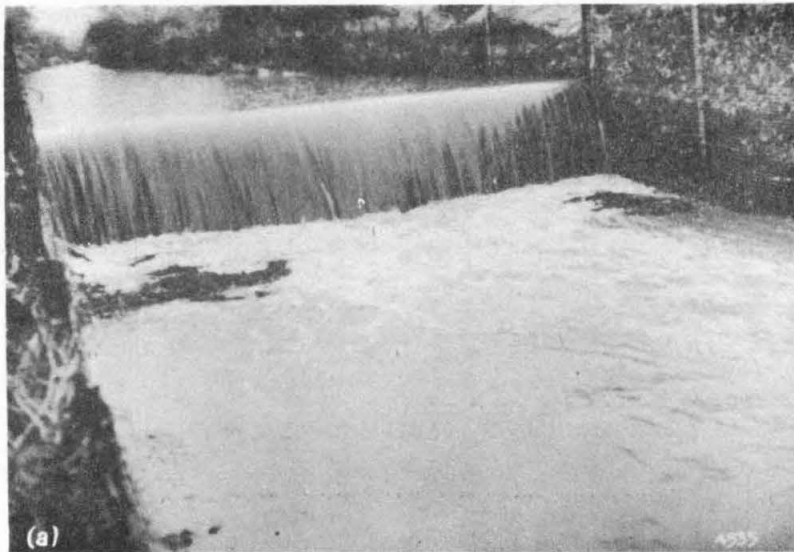
Fig. 7 - FLOW OVER GRADE STABILIZERS

(a) Sheet steel stabilizer. Discharge is about 100 cfs. Width 30 ft and depth at crest about 2 ft. A brush mat is used to form a stilling basin. (b) Pipe and rail stabilizer. Discharge is about 150 cfs. Width 35 ft and depth at crest about 1 1/2 ft. Note partially brushed double fences.

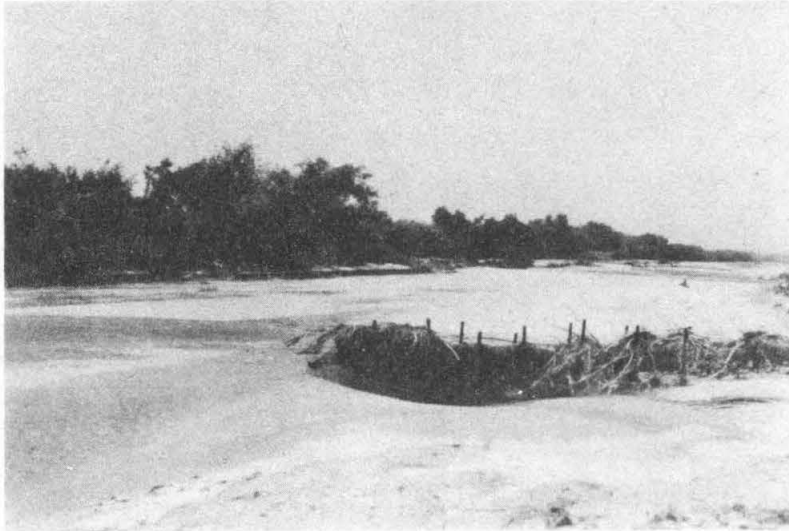
Fig. 8 - GROIN WHICH FAILED

Looking upstream, the flow over and around the groin was sufficient to undermine its supports and cause it to topple downstream.

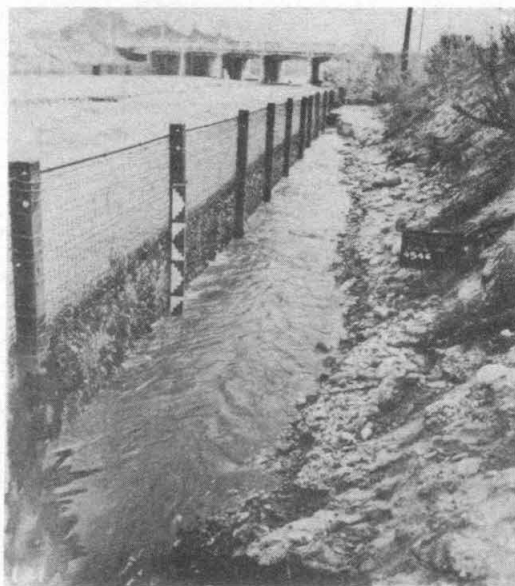
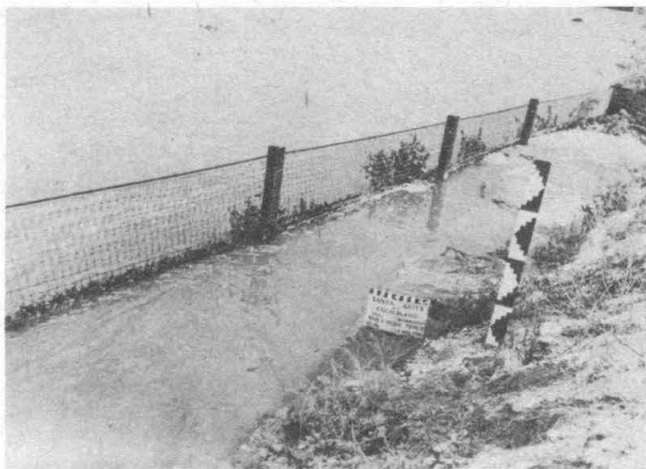
Fig. 9 - FLOW AROUND FENCE AND GROINS

Discharge is 100-300 cfs. All views looking downstream. Fence is rail and wire. (a) Note debris and sediment deposit upstream from groin in center background. Note waves off fence and banks. Depth is about 1/2 ft at fence. Sand waves are forming in channel. (b) Flow right to left. Note debris on fence. (c) Note standing waves off fence and pool upstream from groin. (d) Flow is left to right. Note sand waves breaking upstream in channel and debris on fence.

Most of the streams considered carry, besides their sediment load, large quantities of suspended debris such as tree twigs, leaves, grasses, and the like, part of which gradually attaches itself to any suitable obstruction of the stream. The fence offers a very acceptable place for debris to cling to, after which the suspended sediment deposits around it and helps to mold the leafy tufts and the like into a substance with tough cohesive properties. When attached to the fence such small debris serve principally to dampen the transverse waves which are generated in the main stream and continually lap at the stream banks. The quantity of such debris seems to be greater during the rising stages than during the falling since the potential supply from the contributing watershed is greater during the rising stages. While flows were being observed in the field the debris was actually removed from a part of a fence. This area was recovered in a short time. The fence with such attachments forms a flexible wall that is much more effective in protecting the banks than the fence alone. Figure 9 shows a rail and wire fence in a debris-laden channel along with the flow action upstream from a groin.

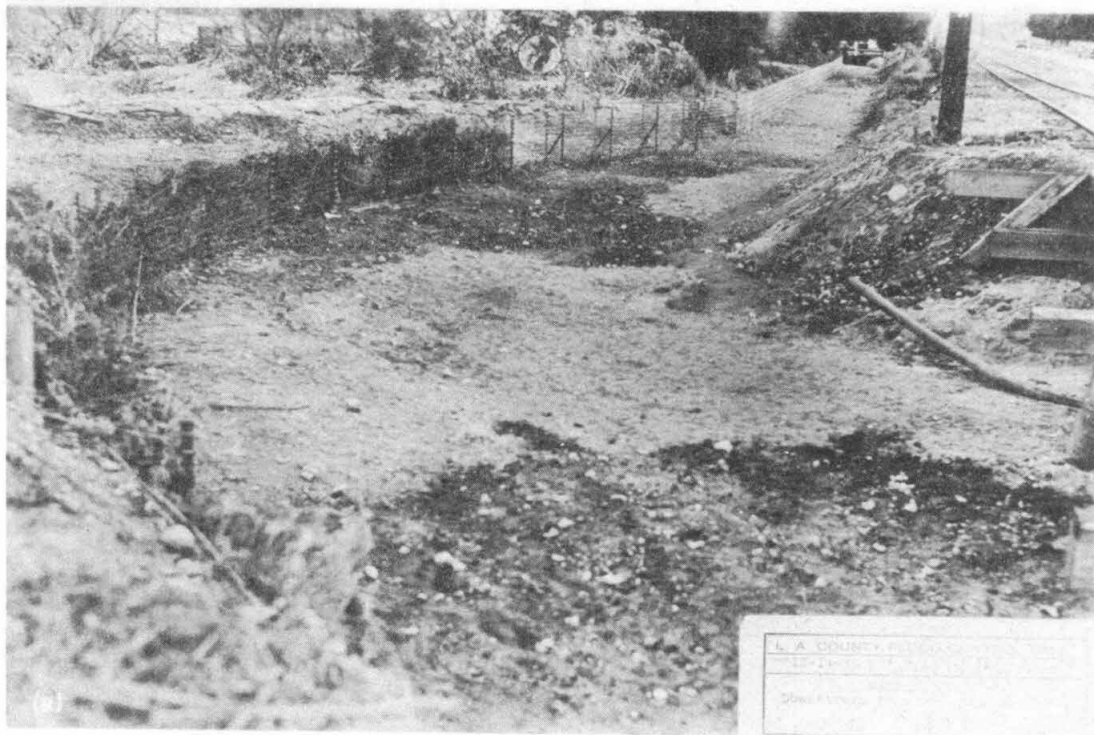
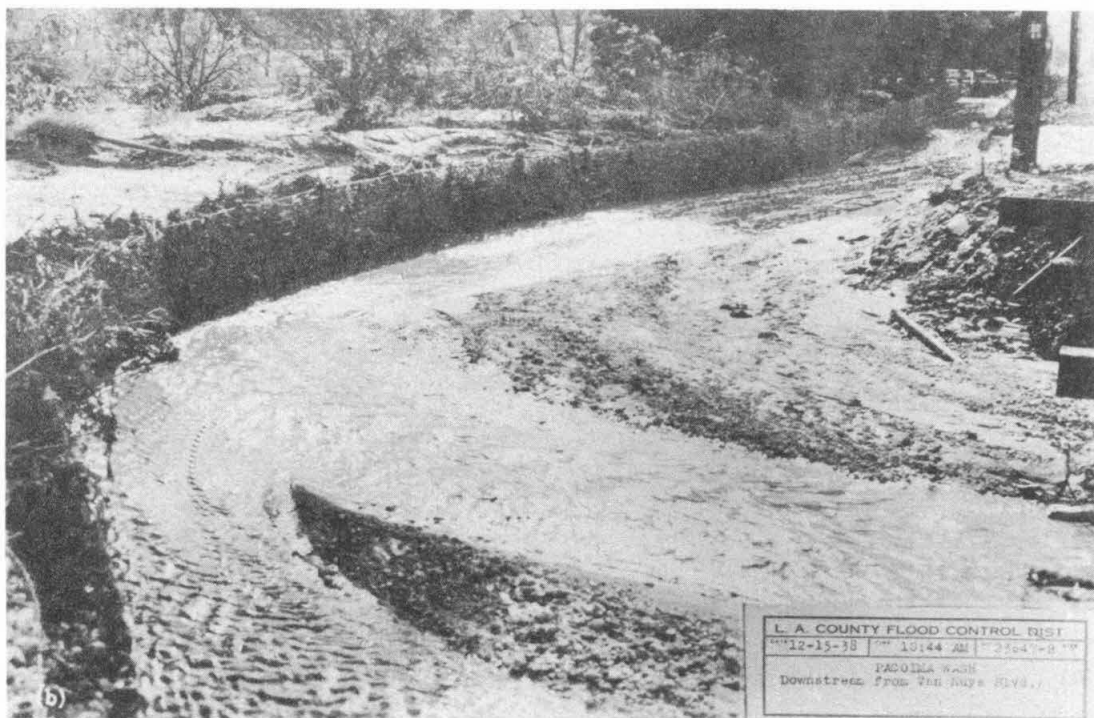
Fig. 10 - PIPE AND WIRE FENCE BEFORE AND AFTER FLOOD

Looking downstream at fully brushed and braced double pipe and wire fence. (a) Before flood. Fence is about 6 ft high. (b) After flood which overtopped fence by 2 ft. Damage was very slight.

the fence is made stable against particularly the dynamic forces of the flowing water. The effect of considerable flow on such a well-designed fence is presented in Fig. 10. Here the fence, located on the outside of a curve as a training wall, was brushed nearly to its full height of about 6 ft. but was so constructed that it was able to turn the flow which overtopped it by about 2 ft. with but very small damage to the fence and the bank behind it. Note in Fig. 10 how the debris from the flood has attached itself to the fence, particularly that portion of the background.

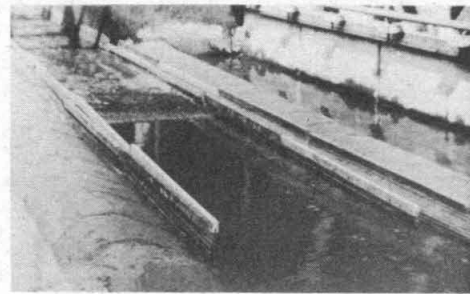
Fig. 13 - PICTORIAL HISTORY OF GROWTH AND BREAKUP OF SAND WAVES IN UNREVETED AND FENCE-REVETED TEST CHANNEL

The action in the unrevetted channel and that with two $\frac{3}{4}$ " mesh fences are shown in parallel vertical columns. (a) Initial flow down channel after start from rest. (b) Surface begins to show undulations due to distortion of bed by sediment movement. (c) Undulations begin to form into wave trains. (d) Waves break upstream.

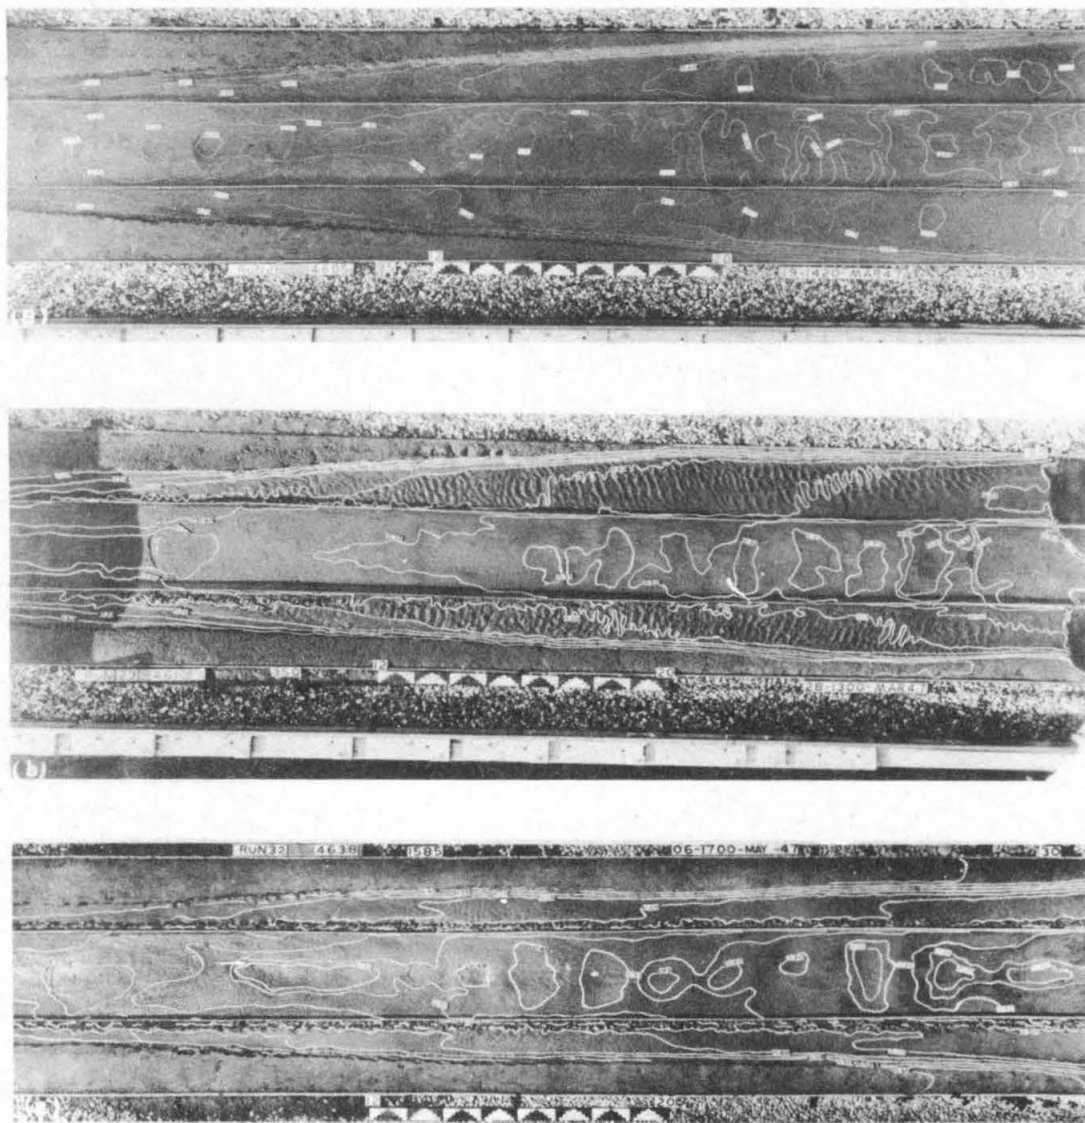
Fig. 24 - COMPARISON OF SCOUR PATTERNS IN FENCE REVETED CHANNEL WITH AND WITHOUT CLOTH TUFTS ON THE BANKS

Fence is $3/4$ " mesh and tufts covered 100% of the wetted bank area at the start of the run. Flow was left to right. (a) Fence alone. E.R. is 1.8. Pattern is typically divergent in the direction of flow and generally symmetrical about the centerline. Run #37. (b) Fence with single tufts on the bank. E.R. is 5.7. Channel divergence appears to have been completed beginning about station 15, especially along the right bank. Run #23. (c) Fence with double tufts. E. R. is greater than 21.9. Channel divergence appears to have been completed beginning at about station 15. Run #32.
